WATER QUALITY, CLARITY, AND ODOUR IMPROVEMENT IN A GOLF COURSE POND USING NANOBUBBLE TECHNOLOGY

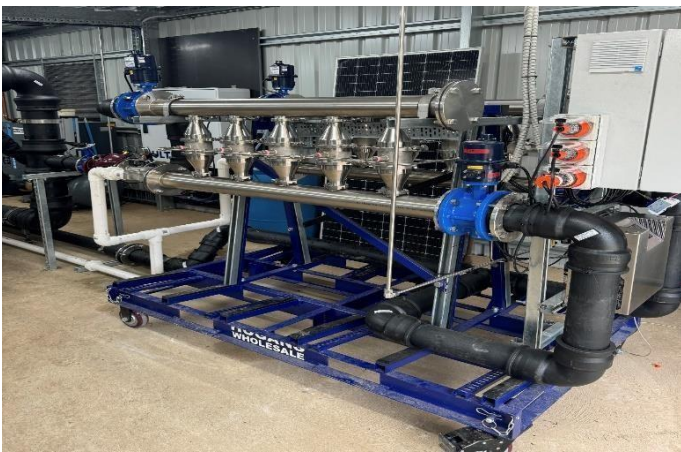
10-Cell Nanobubble Injector System

The installation of a 10-cell nanobubble injector system in the pond was completed on 06 June 2024. Water analysis revealed the following water quality level at the start of the trial: Iron 310 µg/l, Ammonia 0.051 mg/l, Phosphate 0.12 mg/L (all out of range), faecal coliforms: >100 cfu/100 ml; E. coli: >100 cfu/100 ml (moderate). After 3 and half months of operation, we observed the following results: (1) the odour problems were resolved, (2) the green algae disappeared, (3) the visibility in the water was 4 m, and (4) native wildlife returned to the site. Meanwhile, the water analysis showed the excellent following water quality level at the end of the trial: Iron 150 µg/l, Ammonia 0.01 mg/l, Phosphate 0.02 mg/L (all in range), faecal coliforms:<20cfu/100ml; E.coli:<20 cfu/100ml (low). Overall, all water quality parameters showed a significant improvement at the end of the trial. The improvement is remarkable taking into consideration that no chemicals were used. In addition to being environmentally friendly, nanobubble technology can eliminate the risks associated with chemical exposure.

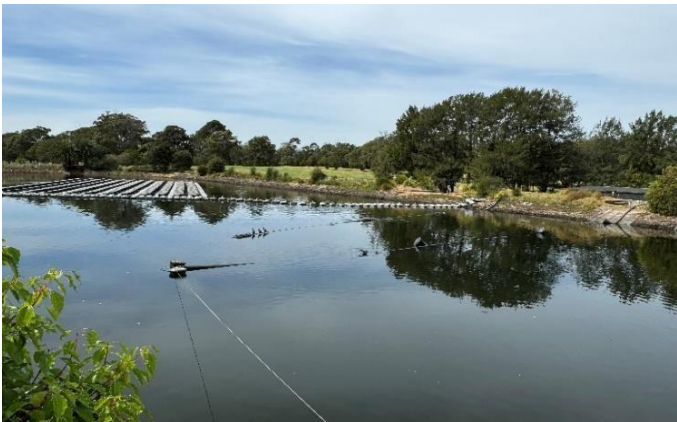
Golf Club's Pond Using Nanobubble Technologies' Injector
